Winter Park Urban Renewal Plan Conditions Survey

The Town of Winter Park

September 11, 2024

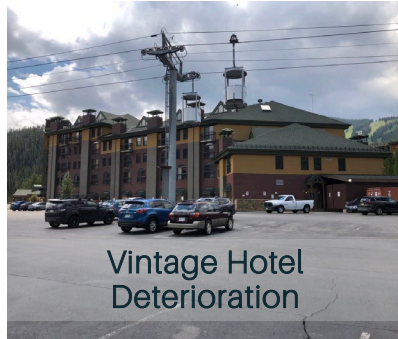
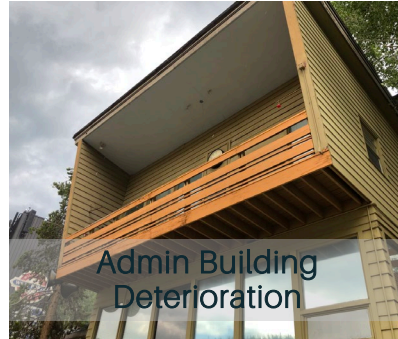
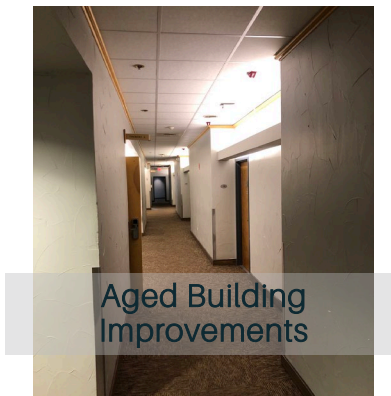
Blighting Factor (a) - Deteriorating Structures

The Vintage Hotel exhibited conditions typical of this blighting factor. The hotel's outside elements featured visible deterioration, especially along the walkways, the façade, and windows. Also, the interior hallways and amenities appeared dated. The proposed development program acknowledges these findings, in that the Vintage Hotel is slated for redevelopment or renovations provided a public private partnership is created. The proposed development envisions significant renovations to the Vintage Hotel that would fundamentally change its appearance. The fact that this hotel is slated for redevelopment underscores the observations noted during the field work.

The West Portal area also featured buildings and outside elements characterized as deteriorating, dilapidated, and aged. The Administration buildings are particularly worn, with visible deterioration of the balconies, steps, and railings. The façade on the building also appears dated, with the wood trim deteriorating in places and paint flaking off. These buildings are also slated for redevelopment, again underscoring how the proposed Urban Renewal Plan is seeking to address this deterioration.

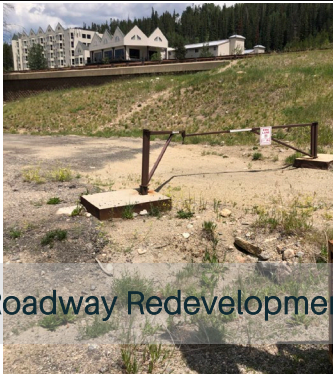
Roadway Redevelopment

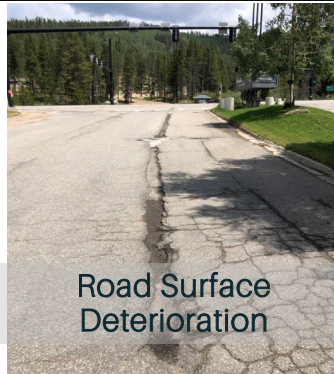
Road Surface Deterioration

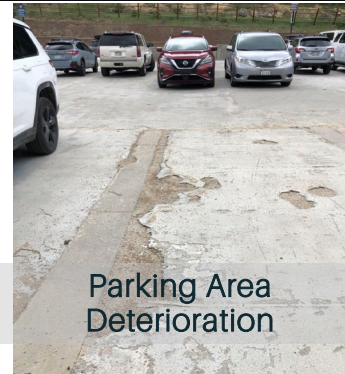
Parking Area Deterioration

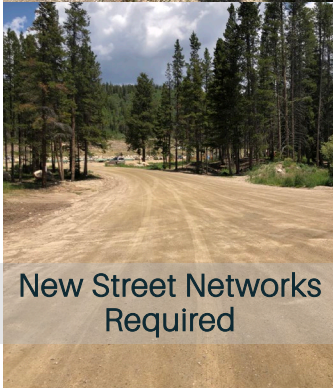
New Street Networks Required

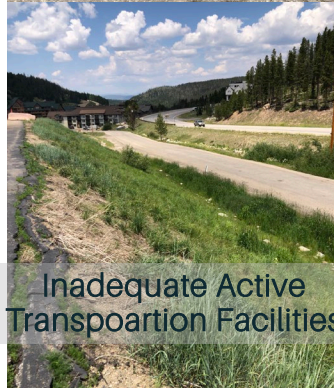
Inadequate Active Transportation Facilities

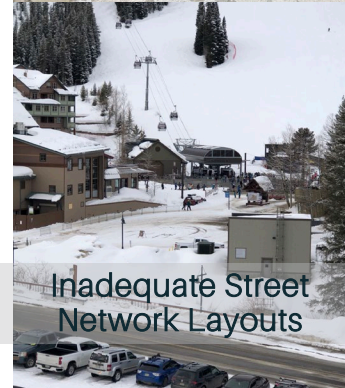
Inadequate Street Network Layouts

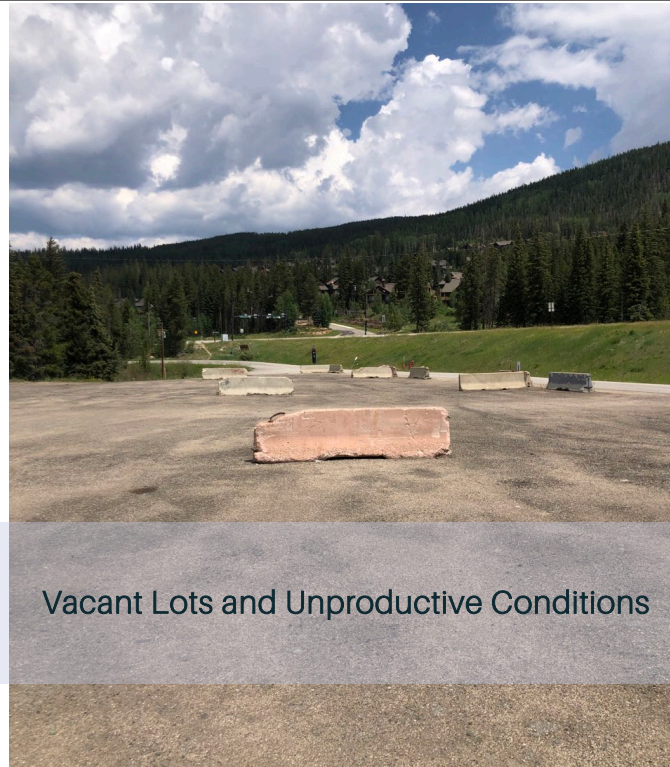
Vacant Lots and Unproductive Conditions

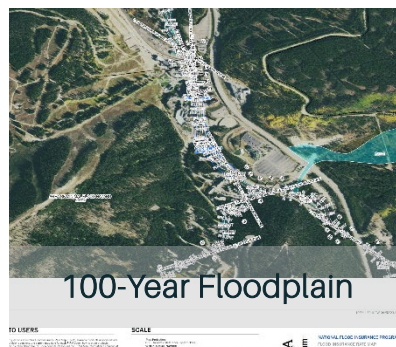
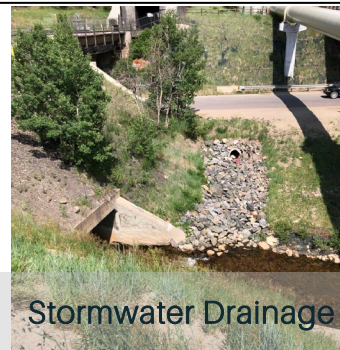
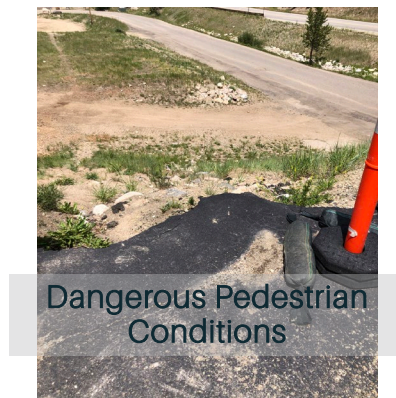
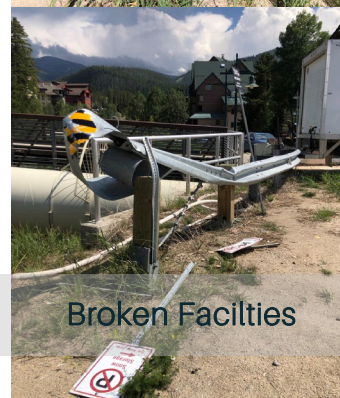
Blighting Factor (d) - Unsanitary/Unsafe Conditions

A notable finding within the proposed Plan area is that it includes floodway and the 100-year floodplain. While the Fraser river is largely contained within the resort area, the Jim Creek development area is almost completely within FEMA's special flood hazard area A. Future development will need to contend with this floodplain, and engineer significant stormwater and floodplain infrastructure to be permitted. The fact that these improvements are currently absent is evidence of this blighting factor.

The absence of internal road networks identified in blighting factor two (2) also contributes to a lack of stormwater facilities and utilities throughout the survey area. The area's vacant parcels notably lack central water and sewer lines, a key condition for cataloging this blighting factor. Preliminary engineering studies detail stormwater sewer improvements throughout the survey area as well. This missing stormwater infrastructure is evidence for this blighting factor. Missing sidewalks, bike lanes, or other active transportation facilities also highlight the area's traffic safety concerns, another example of this factor.

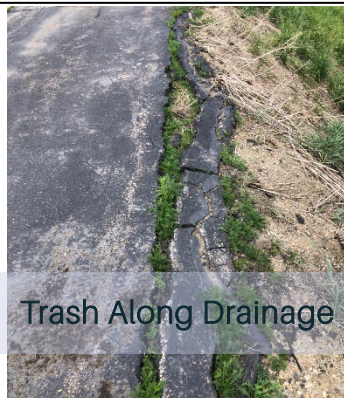
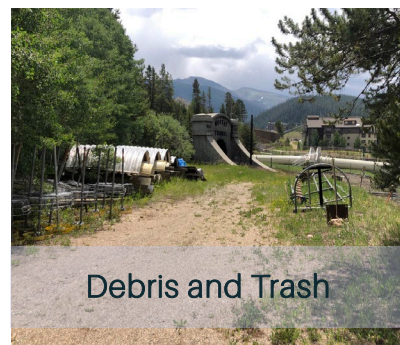
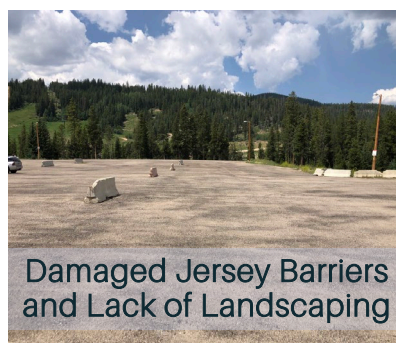
Blighting Factor (e) - Site Deterioration

The site visit identified multiple conditions that blighting factor five (e) lists as evidence for its inclusion in a conditions survey. These conditions included missing public utilities (the area lacks a road network, stormwater/drainage infrastructure, and sewer), missing sidewalks, and trash and debris.

Damaged road networks and sidewalks greatly contributed to including this factor. These transportation facilities are essential to both the existing resort and its proposed development. The fact that active transportation facilities appeared damaged contributed to negative perceptions throughout the survey area.

The vacant parcels slated for redevelopment also exhibited neglected landscaping, and in some case, trash and debris. The presence of trash and debris within the survey area is evidence of site deterioration. This, combined with the fact that the survey area lacks sidewalks and other public utilities, represented evidence for Factor (e)'s inclusion in this report.

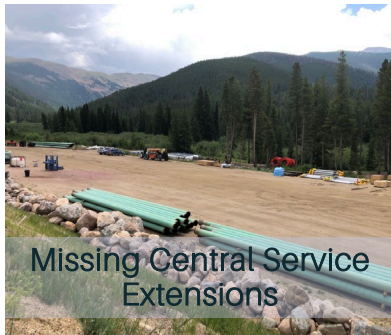
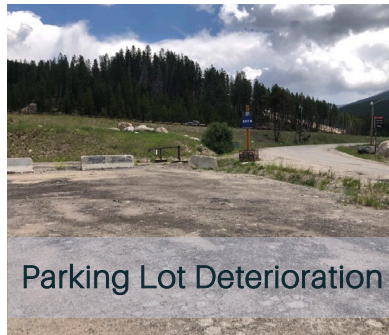
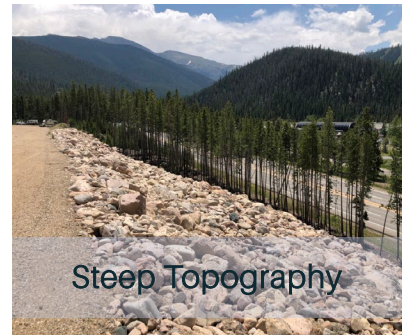
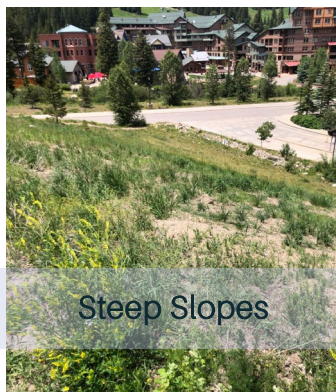
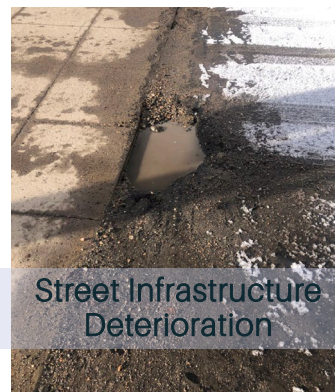
Blighting Factor (f) - Topography or Missing Infrastructure

The site visit found an overall lack of infrastructure throughout the survey area that made it inadequate to facilitate new development as-is. The survey area features numerous vacant, unpaved, surface parking lots. These parcels lack internal road networks, stormwater drainage facilities, central sewer services, and active transportation facilities. The proposed development necessitates the provision of public infrastructure to these areas. Its absence represents a challenge to sound development and justifies the inclusion of this factor.

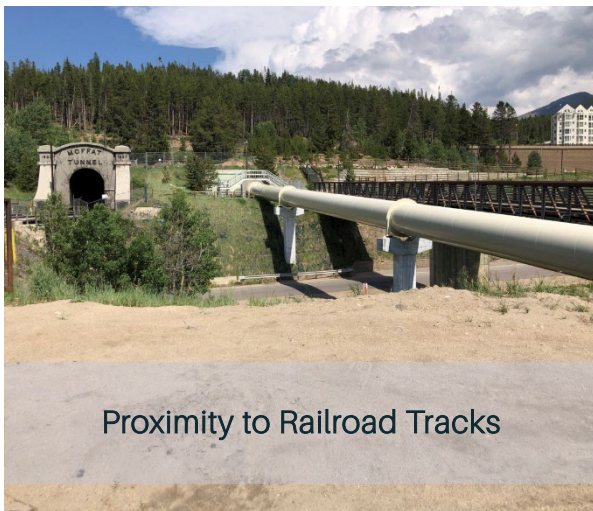
The Plan area also includes a feature that yields a propensity for environmental contamination. The feature is a railroad corridor that transects the Plan area's northern boundary. Railroad lines can contaminate surrounding soils with hazardous materials. Railroad operations often lead to the presence of Recognized Environmental Contaminants (RECs) through various means, including contaminants such as creosote, metals and petroleum products. There is also a propensity for soil contamination to occur from debris/spills associated with railroad activity. This contamination can be the result of years of use, spills, or former maintenance of the lines. The soil contamination may require remediation efforts along the rail line, which can complicate future development within the area. The presence of a railroad is often enough evidence to warrant the inclusion of this factor, even without Phase 1 or Phase 2 Environmental Site Assessments.

Proximity to Railroad Tracks

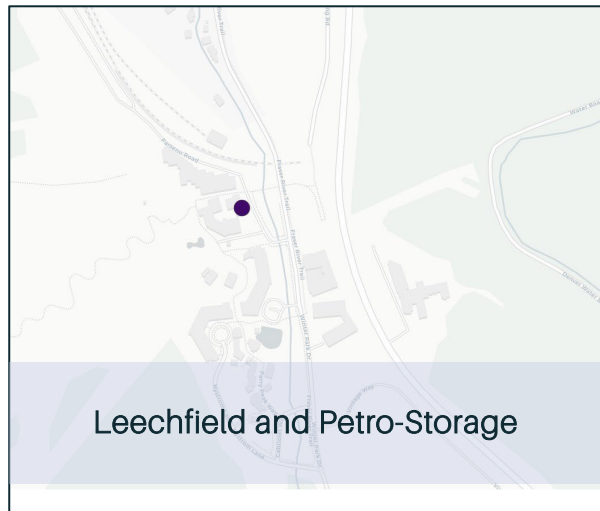
The conditions survey reviewed environmental contamination databases and environmental site assessments on properties within the survey area. This research yielded evidence of possible environmental contamination in the West Portal area, specifically behind the Administration building. This area was formally a leachfield, and later a storage area for diesel fuel. The EPA's databases and community lattice's PEER mapping software indicate that this area has a minor to moderate risk of environmental contamination. Its risk assessment is classified as a four (4) out of five (5), with 5 being the highest risk. A Phase 2 ESA was performed on this area in 2004, which did find evidence of contamination. However, the contamination levels at that time did not exceed regulatory thresholds. Still, the presence of these contaminants and history of use is enough to warrant the inclusion of this blighting factor in the survey area. The Phase 2 ESA also acknowledges that lateral contamination was not tested and therefore could be present in this specific area.

Leechfield and Petro-Storage

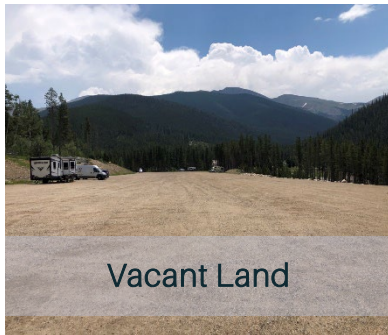
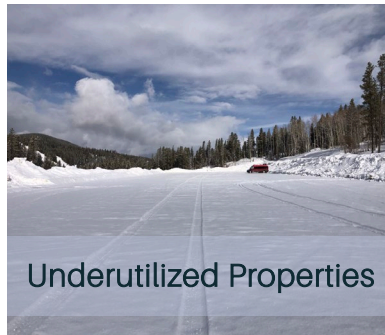
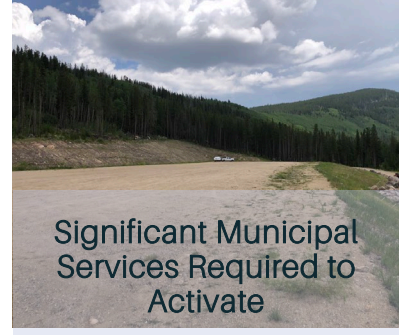
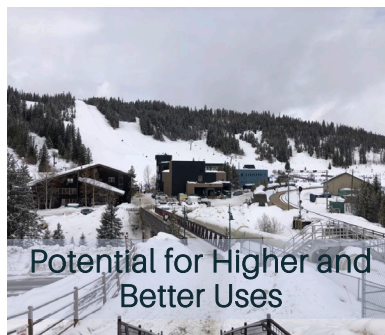
Blighting Factor (f) - Underutilization and Vacancy

The survey area is characterized by vacant and underutilized parcels throughout its ~153 acres. This vacancy and underutilization are conditions that fall under Blighting Factor k.5.
