# CHAPTER II: PARKS

# PARKS

This section summarizes the condition of the Town's three existing parks: Hideaway Park, Confluence Park, and Wolf Park. A combination of narrative text, photographs, matrices and diagrams convey the existing condition of each park. The Town's parks were inventoried through field assessment and a drone survey completed in the Summer of 2023. These field assessments were followed up with community engagement (*see **Community Input section***) and meetings with the Town's staff to identify additional issues and concerns. Staff provided management feedback on select features which is included alongside the field assessments.

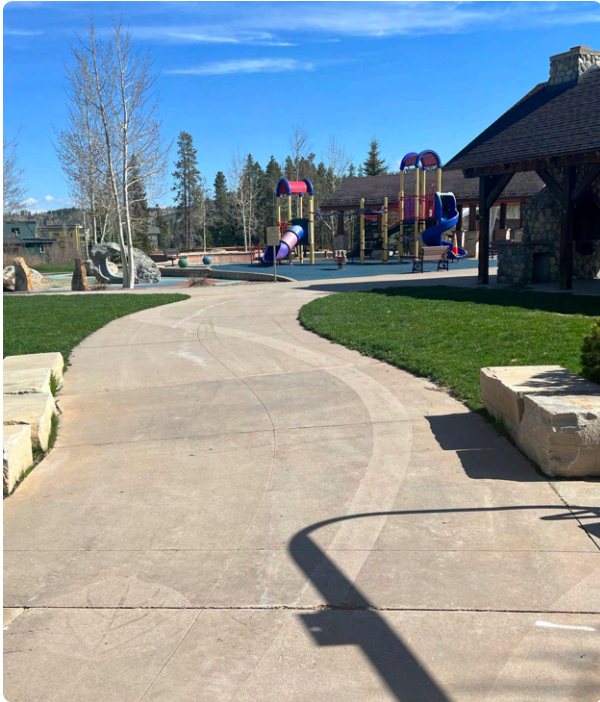
<p><b>Issues and Concerns:</b> Surface-level cracking on concrete stage and ramp.</p> <p><b>Management Feedback:</b> Sandblasted etched patterns were incorporated in the original colored concrete installation. Although the concrete slabs and integral color have held up, the sandblasted etched patterns are no longer legible. Sandblast etching has not held up through multiple seasons of snow removal and is not recommended for future decorative concrete installations. The concrete slab at the north pavilion has a smooth surface that appears to be a troweled finish. This finish is slippery and is not recommended for any exterior concrete. A standard broom finish is recommended for new applications.</p>

FIGURE 2-9. Etched concrete paving at park entrance.

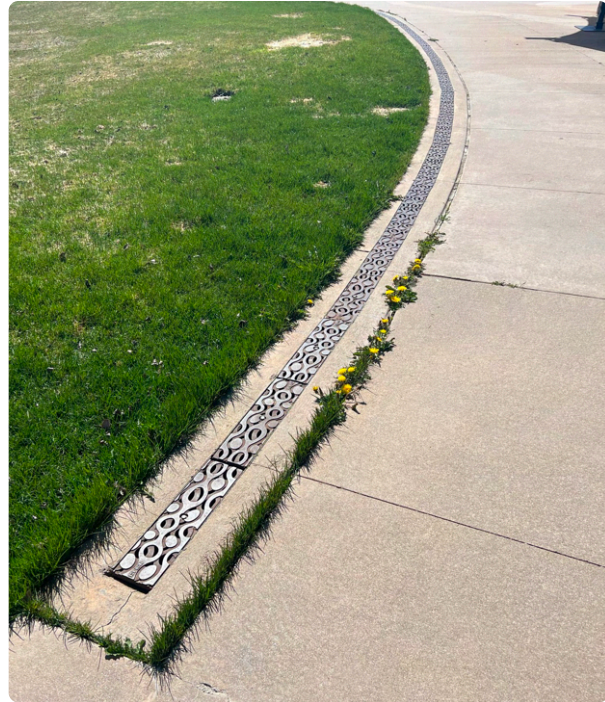
<p><b>Issues and Concerns:</b> The joint sealant where the trench drain meets the surrounding concrete paving is degraded.</p> <p><b>Management Feedback:</b> N/A</p>

FIGURE 2-10. Decorative trench drain.

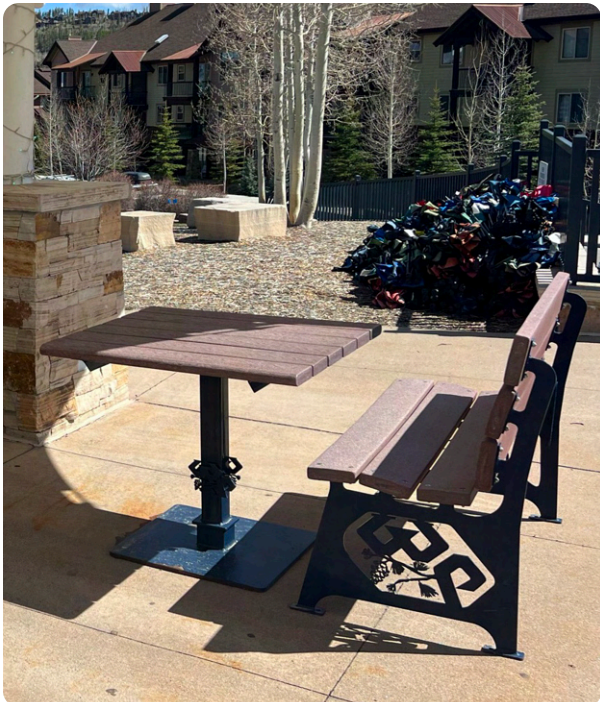
<p><b>Issues and Concerns:</b> While custom-branded furniture aids in giving the space its own unique identity, it can be expensive to replace and repair furnishings over time. The Town of Winter Park has rebranded since these furnishings were commissioned, which will make these furnishings feel dated over time.</p> <p><b>Management Feedback:</b> Bear resistant trash receptacles are essential in all park locations. The blue-colored trash cans can be mistaken for recycling receptacles, which are also blue. Wood material for benches and tables shows more wear over time. Bike storage space is limited especially during bigger events where temporary racks need to be brought in to meet demand.</p>

FIGURE 2-11. Custom bench and cafe table with old Town logo.
