# CHAPTER II: PARKS

# PARKS

This section summarizes the condition of the Town's three existing parks: Hideaway Park, Confluence Park, and Wolf Park. A combination of narrative text, photographs, matrices and diagrams convey the existing condition of each park. The Town's parks were inventoried through field assessment and a drone survey completed in the Summer of 2023. These field assessments were followed up with community engagement (*see **Community Input section***) and meetings with the Town's staff to identify additional issues and concerns. Staff provided management feedback on select features which is included alongside the field assessments.

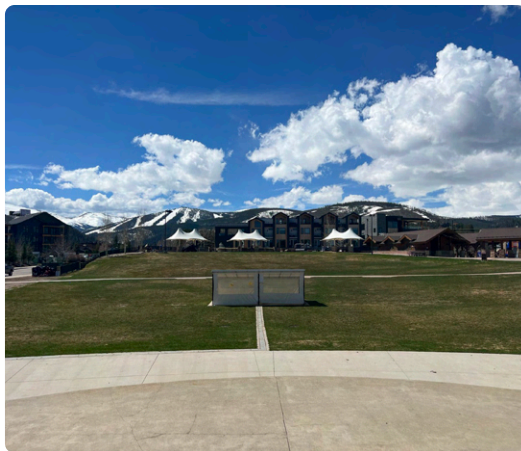
#### Amphitheater Lawn

**Issues and Concerns:** Heavy use of the area has resulted in loss of sod in select locations. Sod is spreading into the adjacent crusher fines paving areas and between joints in concrete paving

**Management Feedback:** Hideaway Park utilizes the most up-to-date WiFi irrigation system. Lawn is easy to maintain, but the bluegrass sod requires a fair amount of water-usage

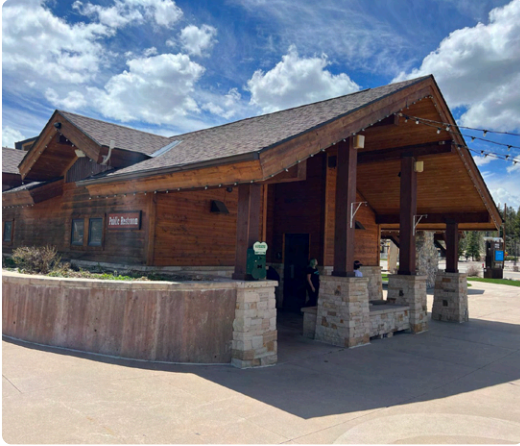
**Restroom**

**Management Feedback:** Restroom building has automatic locks for after hours and motion detectors for security. Stone veneer falls off the sides of the building and needs to be replaced.

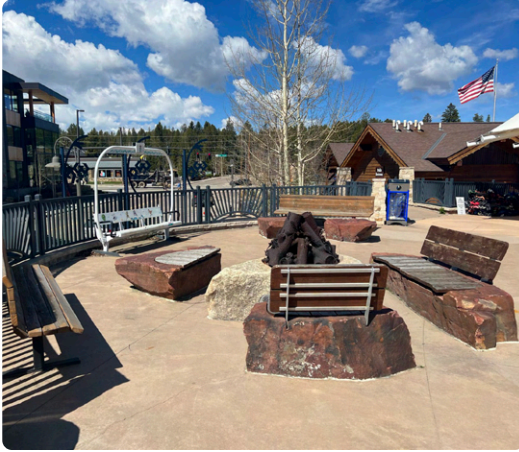
**Fire Pit**

**Management Feedback:** The Town modified the stone slab by boring a new vent hole to disperse heat after the initial installation. Prior to the additional venting, the stone slab melted the original control wires. The wood benches were refurbished in the summer of 2023. The features are entirely custom and are expensive to replace. The park had an additional fire pit but it was removed after the slab cracked and could not be replaced

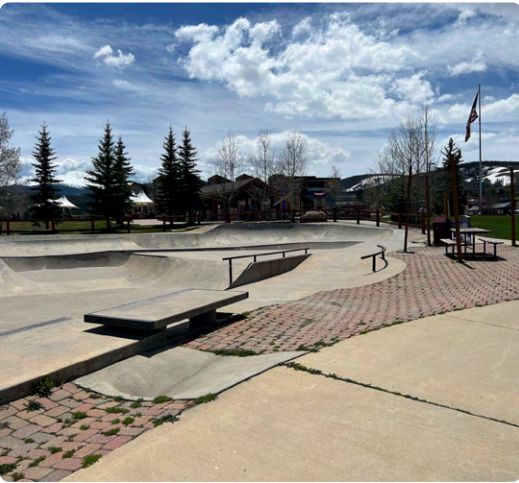
**Skatepark**

**Issues and Concerns:** Concrete shows considerable wear and cracking in multiple locations throughout the skatepark. Vegetation is growing between the pavers.

**Management Feedback:** The skatepark is very popular and only needs minor patching and repairs throughout the year. It lacks a space for new/beginner skaters to practice. The wood posts are not ideal for a shade structure.

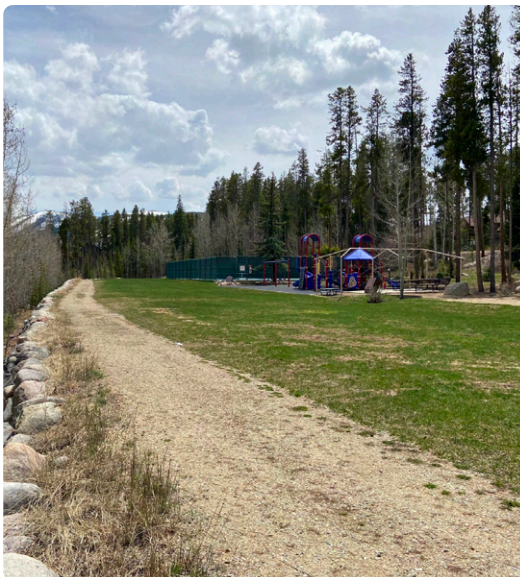
#### Terraced Open Lawn

**Issues and Concerns:** During the Spring, sod was patchy and the drainage inlet was water-logged and eroded.

**Management Feedback:** The irrigation system was not installed properly and does not disperse water evenly across the lawn. The irrigation system oversprays onto adjacent amenities and site features. Lawn space is often used for lawn games.

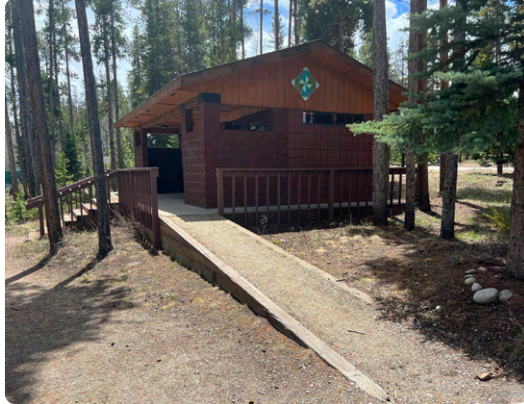
**Restroom**

**Issues and Concerns:** The ramp to the restroom does not meet ADA accessibility standards for slope and edge condition.

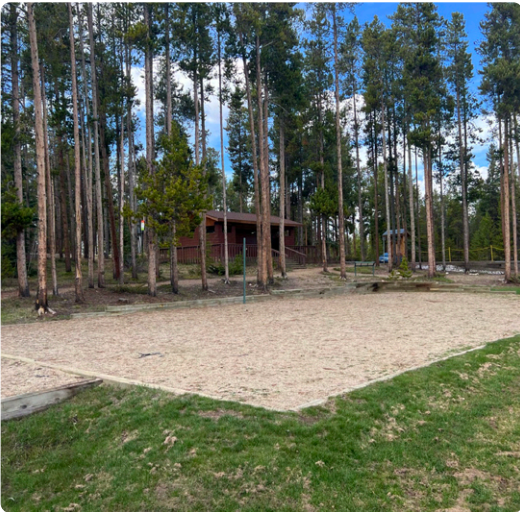
**Volleyball Court**

**Issues and Concerns:** Sod is growing within the sand at the court. Some sections of wood appear to be warping. Sand has hardened with time and is not ideal as a play surface.

**Management Feedback:** The volleyball court is rarely used. The sand is not of play quality and is hard to keep clean and maintain. The two new volleyball courts recently installed at the Fraser Sports Complex receive more use and are in better condition.

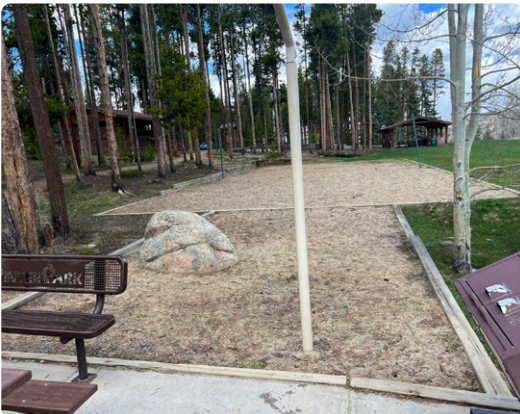
**Sand Pit**

**Issues and Concerns:** This feature is not distinguishable and usable as a sand pit. The sand has hardened over time. Due to its material choice and location, it functions a transition space between the sand volleyball court and playground.

**Management Feedback:** This area used to have digging play equipment, but it was removed after it was damaged. There are no plans to replace the digging play equipment.

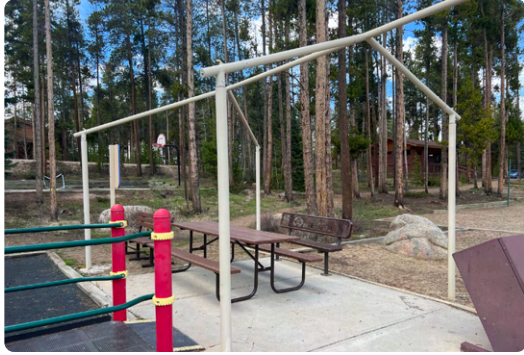
**Sun Shade**

**Issues and Concerns:** Concrete pad is cracked at the footer location and the concrete pad is being undercut with the underside exposed.

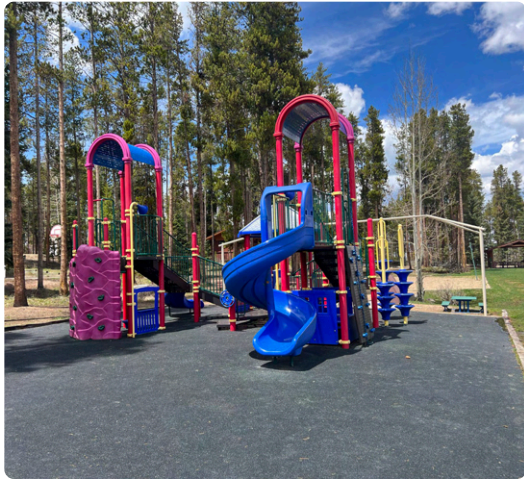
**Playground**

**Issues and Concerns:** Poured-in-place rubber surfacing is peeling, petrified and warping. At the northeast corner, the rubber surfacing is failing and was heavily water-logged. Vegetation is growing between the wood mow edge and the rubber surfacing.

**Management Feedback:** The playground and poured-in-place rubber surfacing have reached the end of their material life cycle.

- ▶ **Playground:** A new playground shall replace Wolf Park's current outdated play equipment. Aesthetics of the playground should reflect the forest environment surrounding the park and provide play opportunities different from those currently offered at other parks. *Refer to section 6.3 Playgrounds of the Outdoor Recreation Standards chapter.*

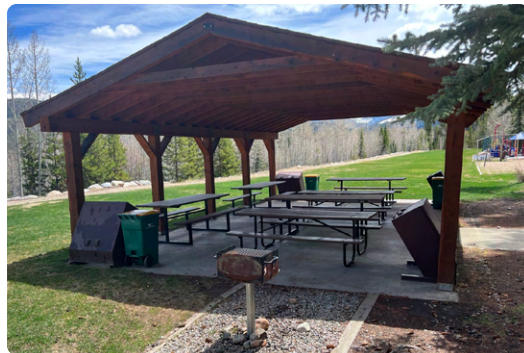
**Pavilion**

**Issues and Concerns:** Concrete pad is cracked at ground connection of the posts.

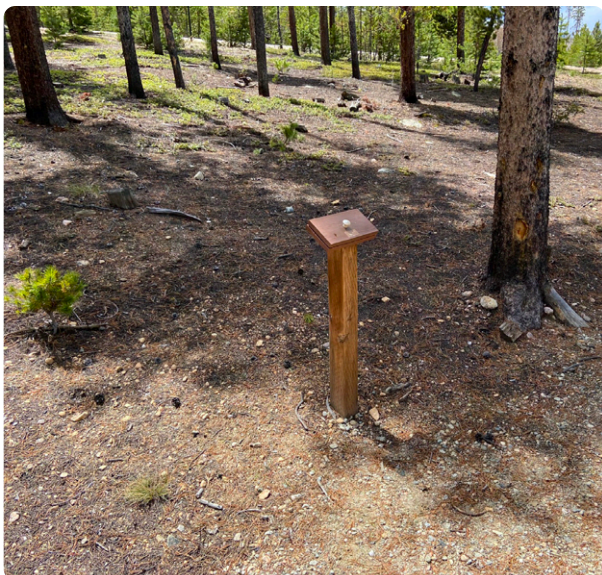
FIGURE 2–34. Interpretive sign along Alpine Trail.

<p><b>Issues and Concerns:</b> Many of the interpretive features, maps and signs are outdated. The wood interpretive signs are damaged with missing pieces including markers, handles, and signage.</p> <p><b>Management Feedback:</b> The map within the kiosk at the parking lot is oriented in the wrong direction.</p>

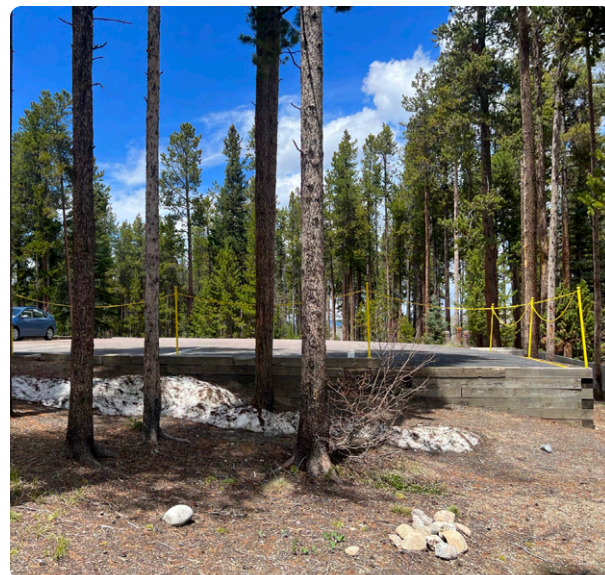
FIGURE 2–35. Terraced parking area near entrance.

<p><b>Issues and Concerns:</b> Surface level cracks. Vegetation is growing between the retaining wall and asphalt edge. The post-and-chain fence feels like an interim fix to addressing the drop-off safety concern along the edge of the parking lot.</p> <p><b>Management Feedback:</b> The post-and-chain fence was installed along the edge of the parking terrace to prevent vehicles from driving off the edge. It needs to be partially removed during the winter season to plow and store snow within the parking lot. Since most of Wolf Park becomes inaccessible during the winter, the parking lot acts as a trailhead for directing visitors to the Alpine Trail.</p>
