Winter Park Urban Renewal Plan Conditions Survey

The Town of Winter Park

September 11, 2024

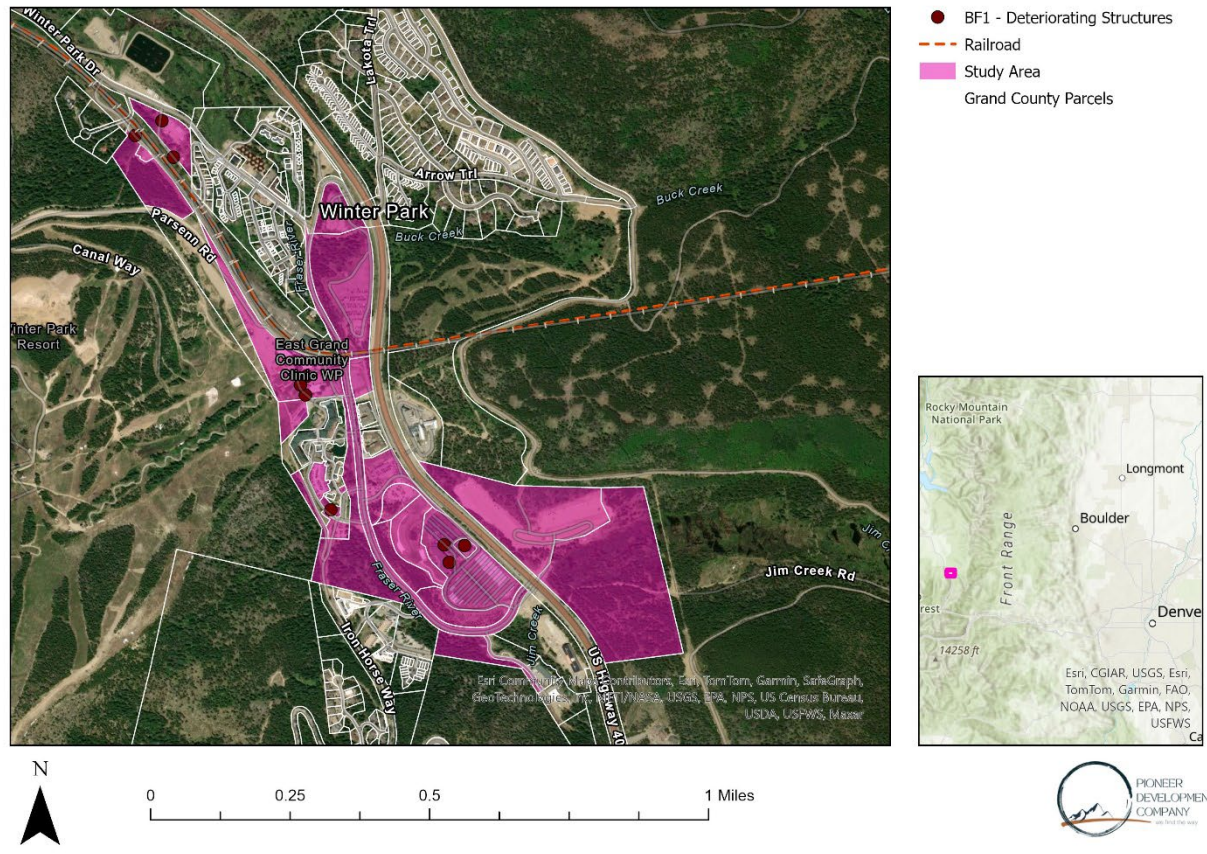
Blighting Factor (a) - Deteriorating Structures

Although these building improvements represent a small portion of the proposed Urban Renewal Plan, their location is central to the Ski Resort's operations. Their deterioration foments negative perceptions throughout the survey area, especially since West Portal envelops the base area and the Vintage Hotel is the only existing hotel in the ski area. These characteristics and observation are why this report concluded that blighting factor 1 is present in the conditions survey area.

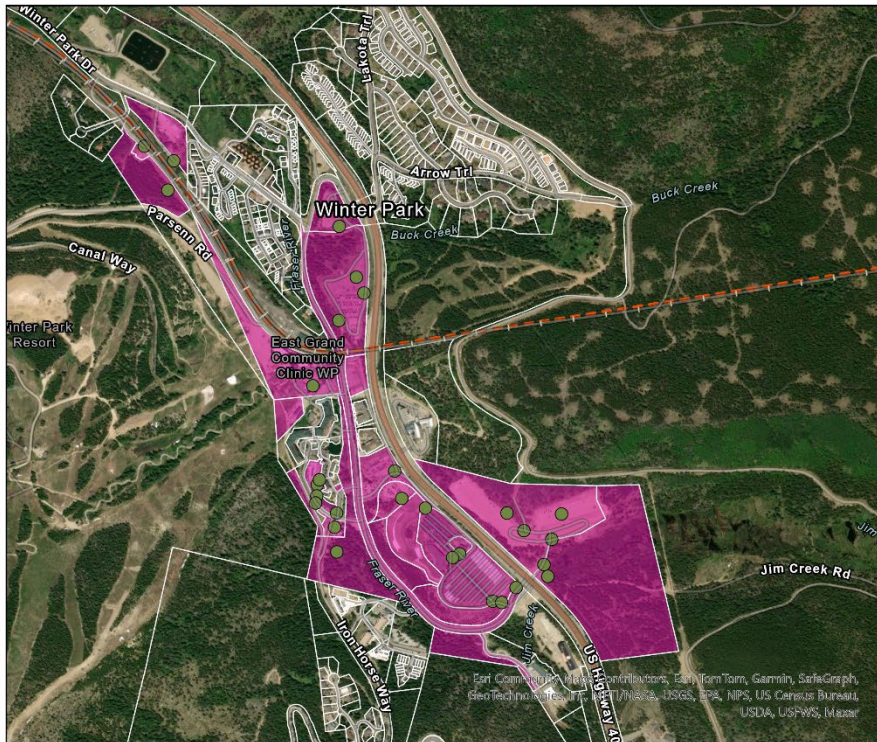
Blighting Factor (b) - Defective Streets

Inadequate traffic safety facilities were also observed during the site visit. Missing sidewalks and bicycle lanes made transit by foot/bike unsafe along Winter Park Drive, Nystrom Lane, and Parsenn Road. There was also significant deterioration of sidewalks in these areas. This deterioration, and need to develop new traffic facilities, contributed to this report finding evidence for this blighting factor.

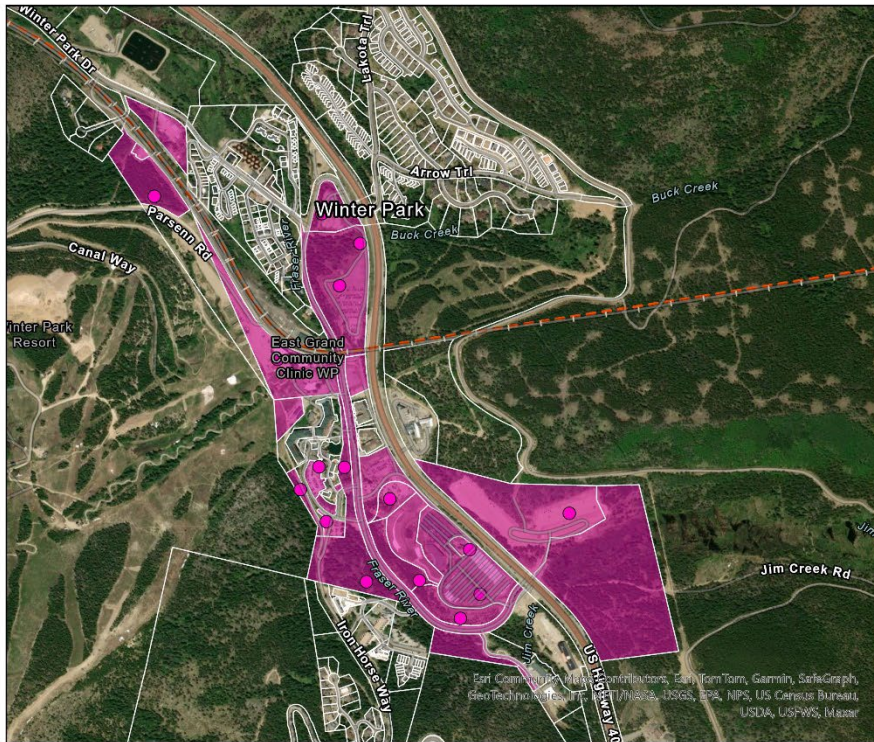
Blighting Factor (c) - Faulty Lots

The presence of multiple properties that exhibit these conditions justified this blighting factor's inclusion.

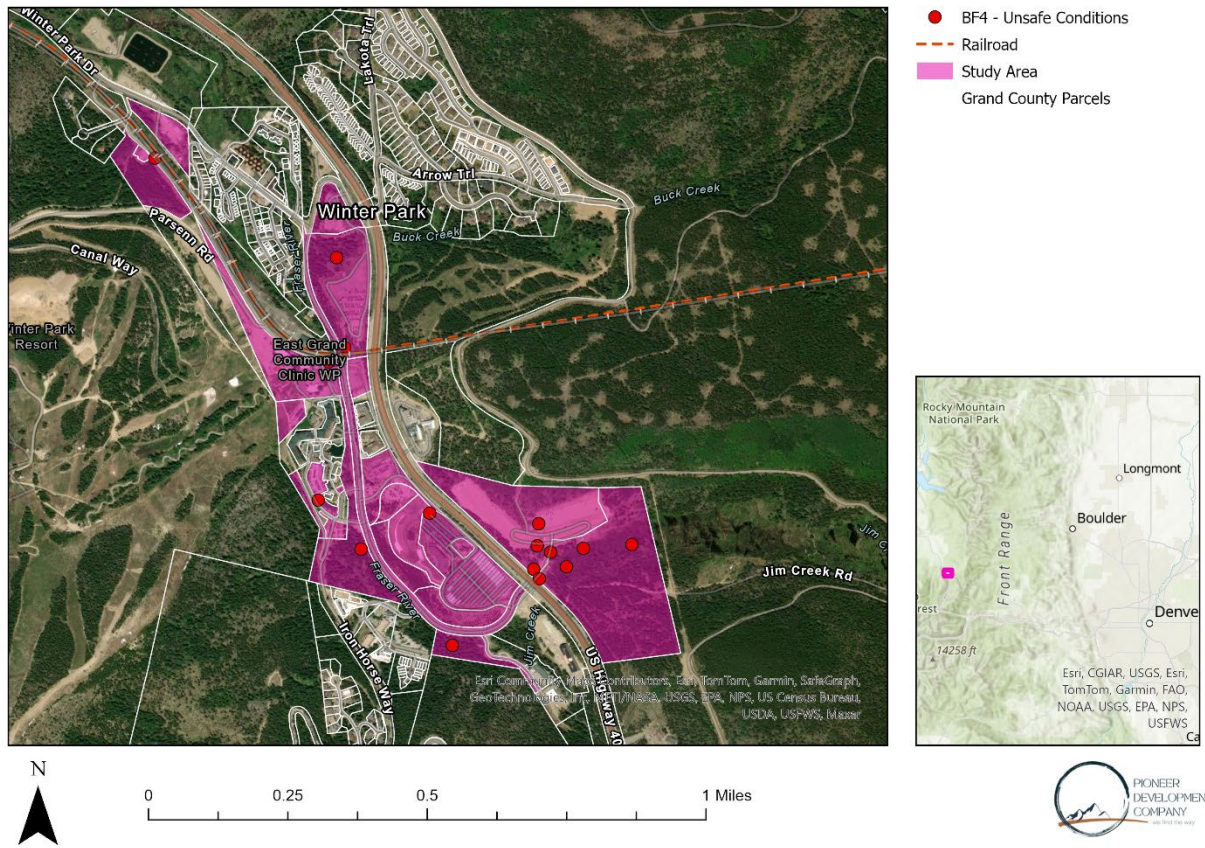
Blighting Factor (d) - Unsanitary/Unsafe Conditions

The combination of these conditions justifies the inclusion of blighting factor four within the survey area.

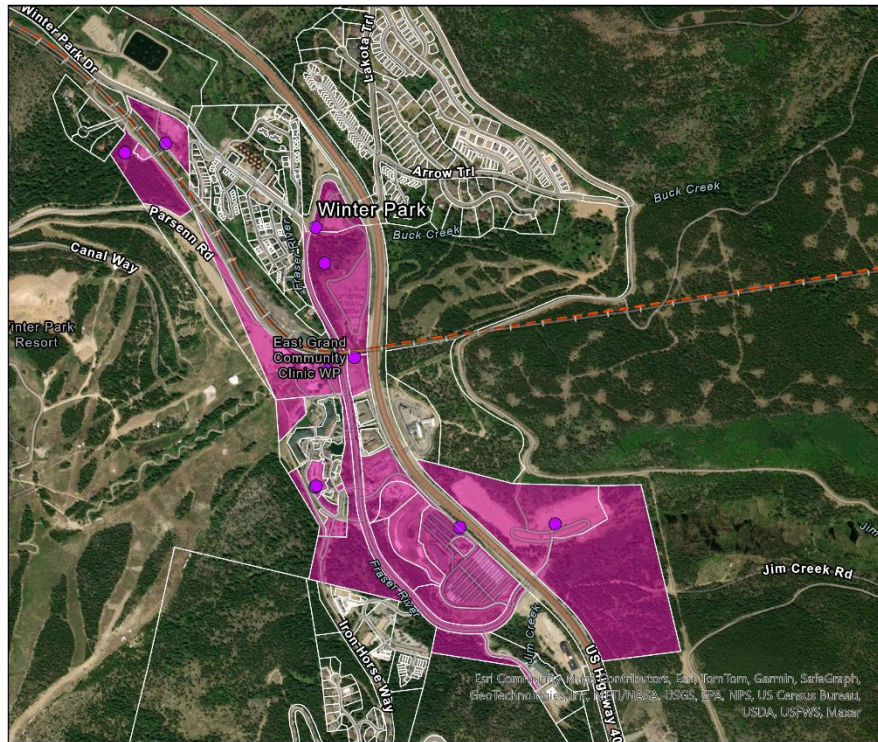
Blighting Factor (e) - Site Deterioration

The vacant parcels slated for redevelopment also exhibited neglected landscaping, and in some case, trash and debris. The presence of trash and debris within the survey area is evidence of site deterioration. This, combined with the fact that the survey area lacks sidewalks and other public utilities, represented evidence for Factor (e)'s inclusion in this report.

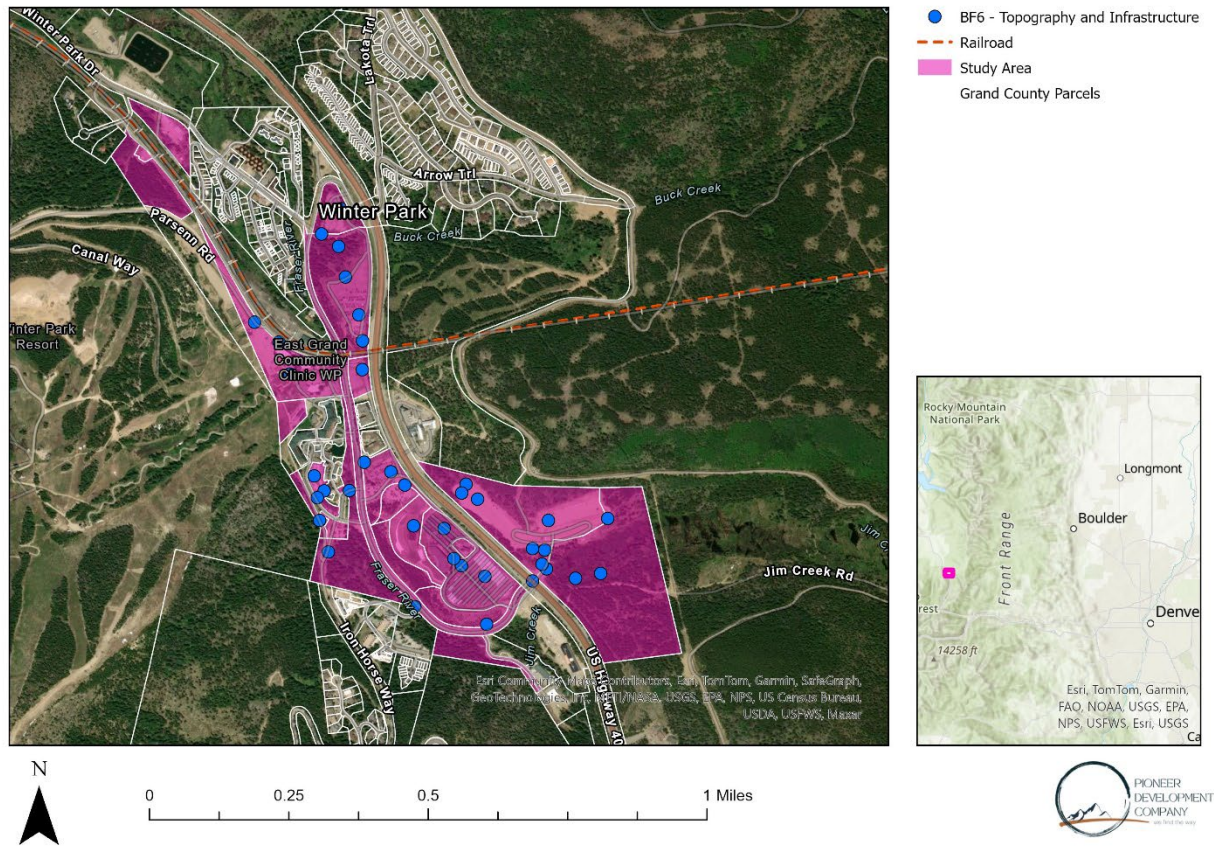
Blighting Factor (f) - Topography or Missing Infrastructure

These conditions exhibit evidence of this blighting factor within the survey area.

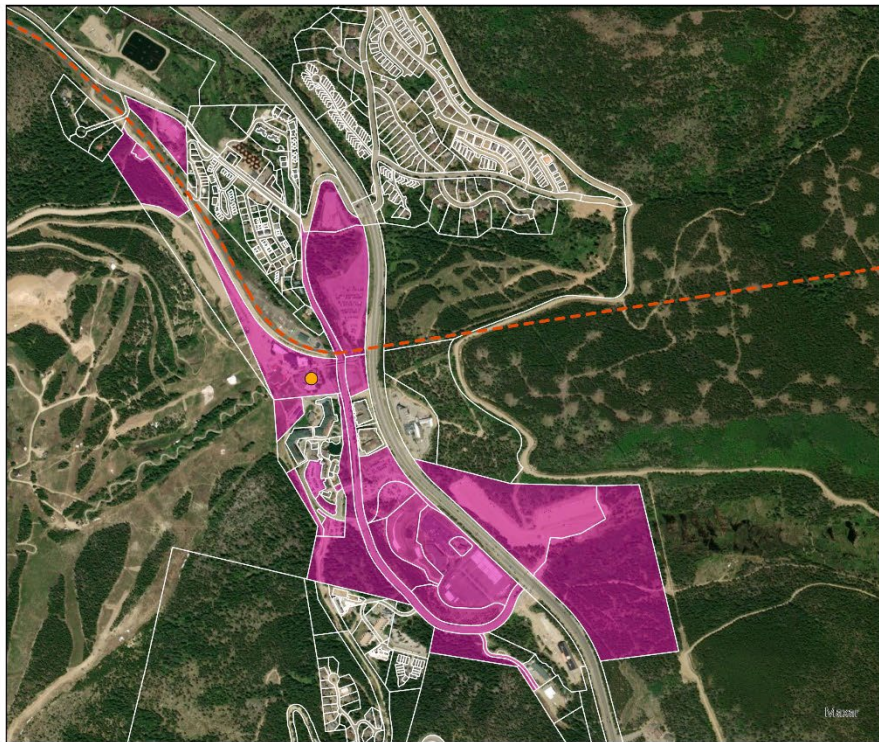
Blighting Factor (f) - Environmental Contamination

These potential contaminants present challenges for redeveloping the properties adjacent to the rail corridor and in the West Portal area. Remediation efforts for contaminated soil can be costly and time-consuming, impacting project timelines and budgets. Additionally, depending on the severity of the contamination, the developer may be required to implement specific mitigation strategies during construction to protect workers and future residents. Therefore, Phase 1 and Phase 2 Environment Site Assessments are advisable before development commences. These tests will determine the extent of the blighting factors and whether a remediation plan is necessary.

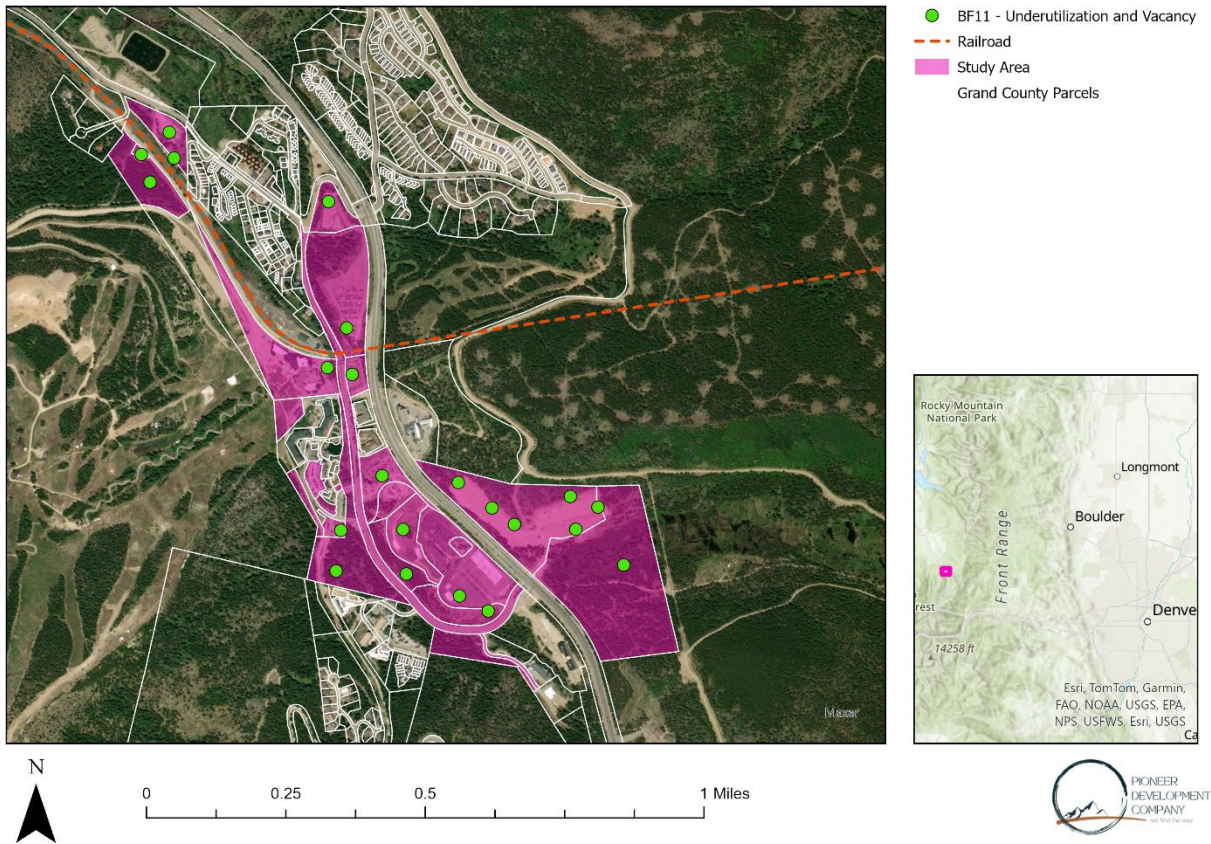
Blighting Factor (f) - Underutilization and Vacancy

The survey area's existing conditions underscore the inclusion of this blighting factor. Fortunately, the survey area's development plans for these properties are aligned with the Town's desired uses and planned unit development for the land.
